CONCRETE DAM EVOLUTION

The Bureau of Reclamation's Contributions

Gregg A. Scott¹, P.E., Technical Specialist, Structural Analysis and Geotechnical Groups Larry K. Nuss ¹, P.E., Technical Specialist, Structural Analysis Group John LaBoon¹, P.E., Manager, Waterways and Concrete Dams Group

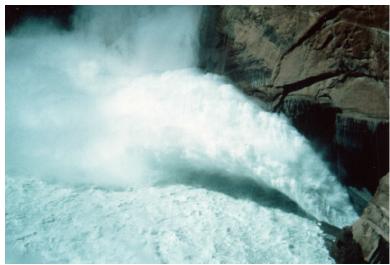
Basin X (tunnel flip bucket), Spillway Discharging Approximately 27,000 ft³/s - Glen Canyon Dam, AZ

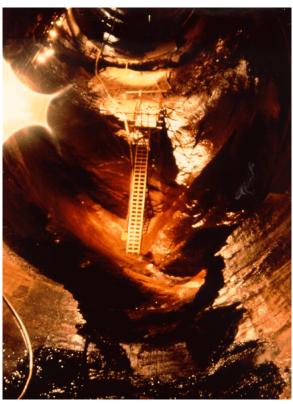
1983 Cavitation Damage in the Left Spillway Tunnel. The "big hole" extends approximately 27 feet below the tunnel invert - Glen Canyon Dam, AZ

A third major advancement in evaluating hydraulics for high concrete dams involved the understanding of cavitation. Although Reclamation had investigated cavitation damage and implemented repairs since 1941, the understanding and methodology to adequately mitigate cavitation damage was not fully developed until after significant cavitation damage occurred at Glen Canyon and Hoover Dam tunnel spillways as a result of flooding in 1983. Prior to this, standard practice was to specify very stringent concrete finishes for flow surfaces associated with discharge velocities greater than 75 ft/s. The concrete finishes for these flow surfaces were very difficult to achieve in the field. A more effective method had actually been employed in 1961 and 1969 with the installation of aerators to address the cavitation damage which occurred at Grand Coulee Dam outlet works tubes and spillway chute, and the Yellowtail Dam spillway, respectively. The installation of the aerator for Yellowtail Dam spillway is thought to be the first of its kind, and after which, it was noted that aerators were being installed worldwide. It is interesting to note that research had already illustrated the effectiveness of extremely small quantities of air entrained in flowing water in significantly reducing the tendency for cavitation damage. However, it was not until the mid- to late-1980's that sufficient research, design, and experience had been gained to change Reclamation's approach to mitigating cavitation potential. Cavitation was found to be the result of formation and collapse of vapor cavities at abrupt changes in geometry of the flow surface. Resulting from an eight year effort, EM 42, Cavitation

Today, as standard practice in the technical evaluations of existing and new spillways, the cavitation potential is evaluated by first evaluating the cavitation index (s) profiles at different discharges. Based on cavitation index profiles, the required surface tolerances are determined as a function of the minimum value of cavitation index. If the cavitation index is less than 0.2, cavitation

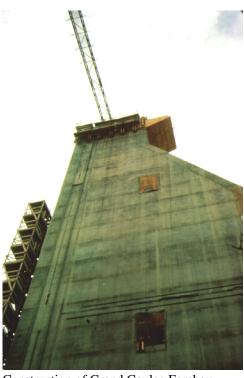
Construction of Grand Coulee Forebay Dam, WA (Note unkeyed contraction joint)

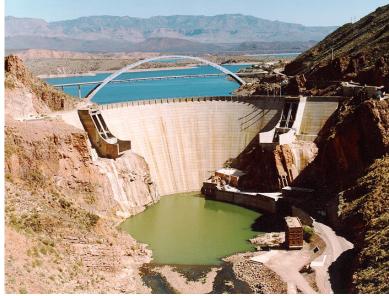
Modified Theodore Roosevelt Dam, AZ - Completed and rededicated in 1996.

Other modifications to the dam included construction of a lake tap and tunnel system to provide a new outlet works and power penstock. New mass concrete thrust blocks were constructed on each abutment to fill the gap formed by the original spillway cuts. New spillways were constructed through each thrust block. Hydraulic model studies were used in the hydraulic design of the spillways. Spillway flows enter a diverging chute and flip structure before plunging to an excavated basin in the river channel below. The spillway alignments cause the discharge jets to impinge at or above tailwater level, while both spillways are operating under higher reservoir heads.
